Confidential Pool Inspection Report

LOCATED AT:
889 Ashland St
Ashland, VA 23005

INSPECTED ON:
Thursday, November 16, 2023

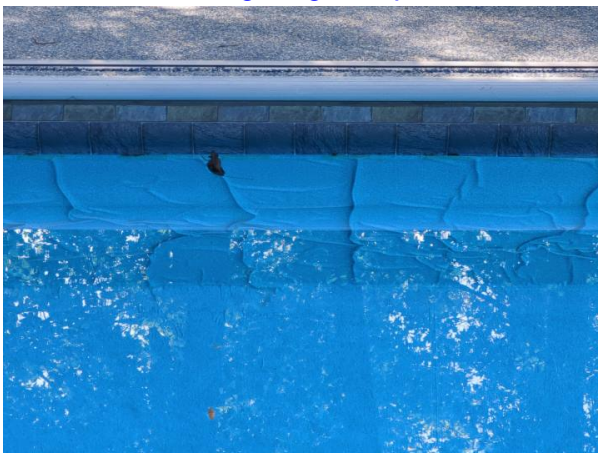
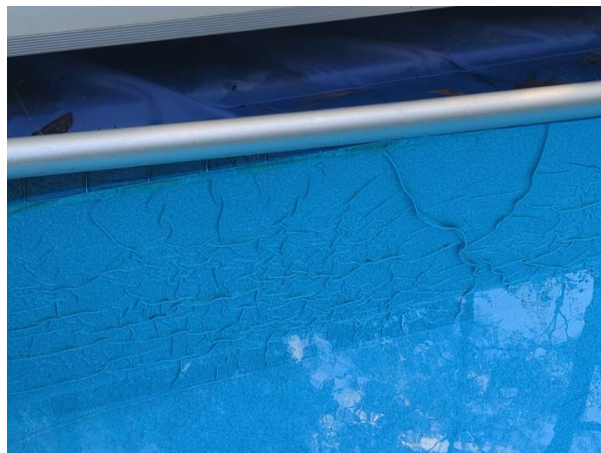
3: There were wrinkles in the liner which can allow tearing. This should be repaired as needed. Recommend budgeting to replace.

s-3: There were wrinkles in the liner which can allow tearing. This should be repaired as needed. Recommend budgeting to replace.

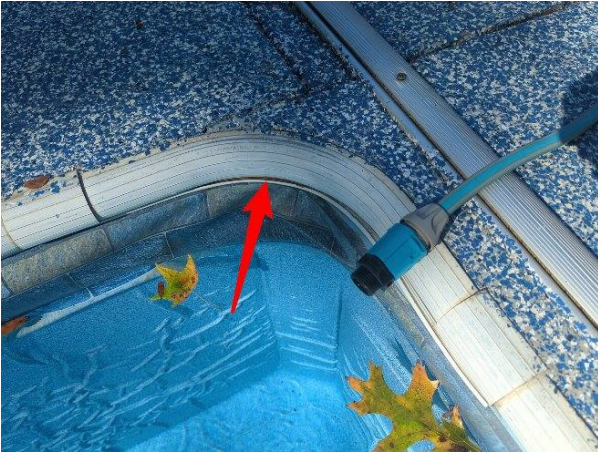
4: The vinyl liner is detached in several areas.

s-4: The vinyl liner is detached in several areas.

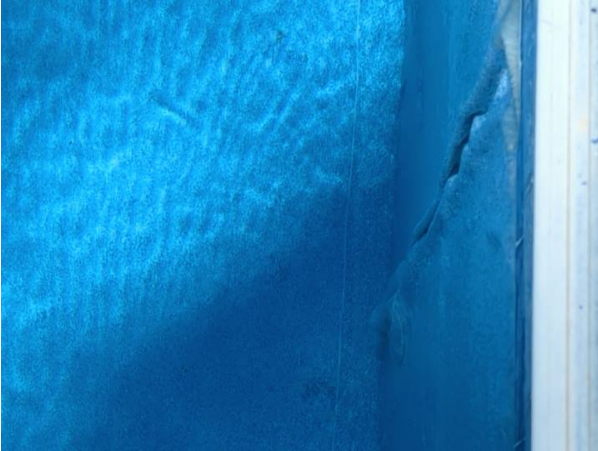
5: The vinyl liner had some prior patching. Liners generally last about 7-12 years before requiring replacement, but can be damaged at any age. Discussing with the seller to determine need for patches, and if issues were resolved or ongoing is recommended.

s-5: The vinyl liner had some prior patching. Liners generally last about 7-12 years before requiring replacement, but can be damaged at any age. Discussing with the seller to determine need for patches, and if issues were resolved or ongoing is recommended.

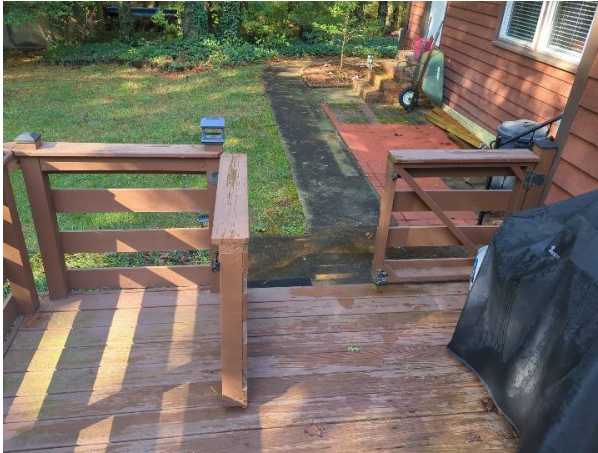
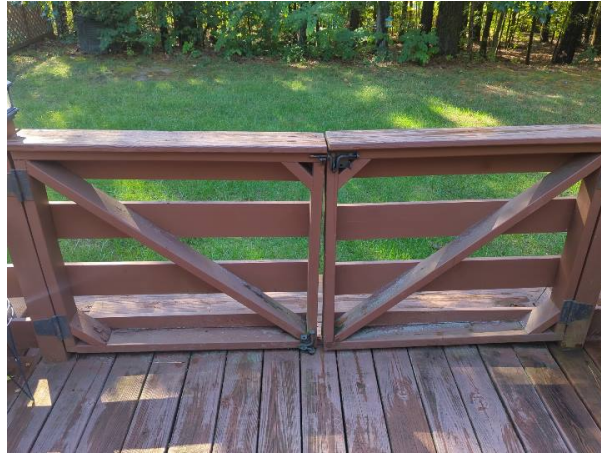
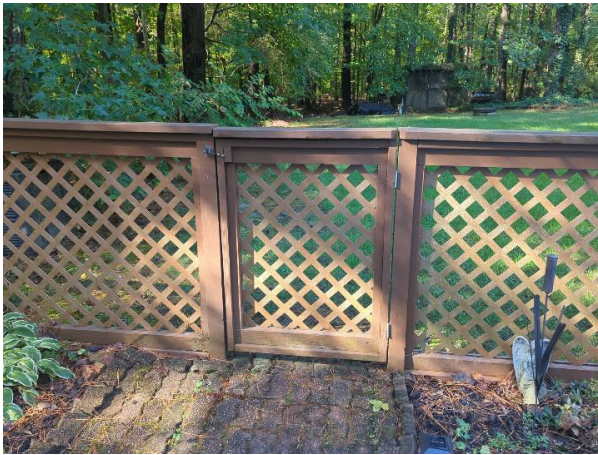
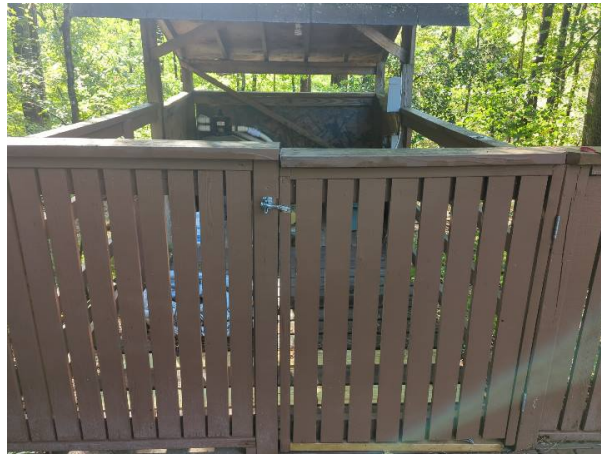
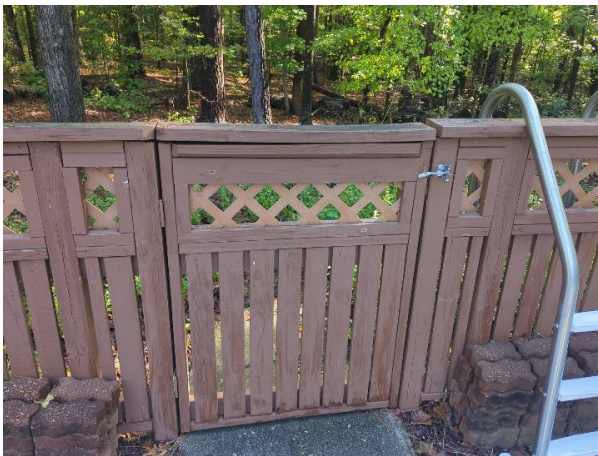
10: The gates were not opening outward, self latching, or closing which should be corrected for safety.

s-10: The gates were not opening outward, self latching, or closing which should be corrected for safety.

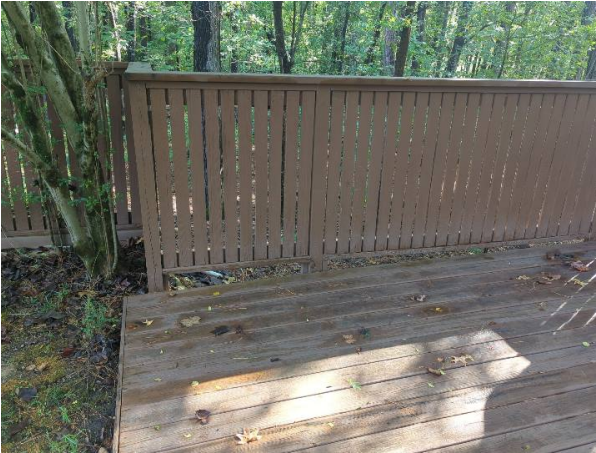
11: The gap between the fencing and the decking near the pool pump was too large. Recommend correction for safety.

s-11: The gap between the fencing and the decking near the pool pump was too large. Recommend correction for safety.

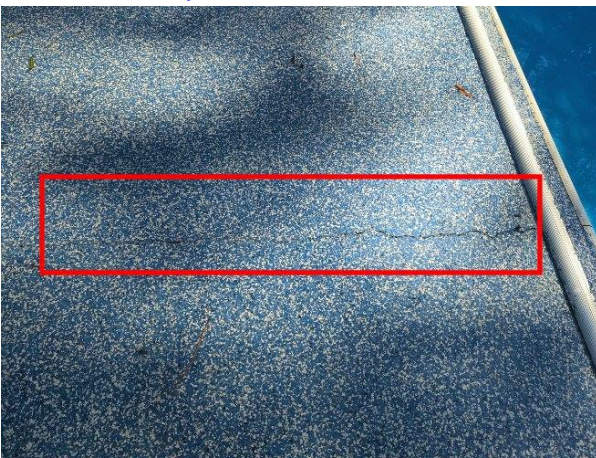
12: There was cracking observed at the pool deck. Sealing to prevent further damage during freeze/thaw cycles is recommended.

s-12: There was cracking observed at the pool deck. Sealing to prevent further damage during freeze/thaw cycles is recommended.

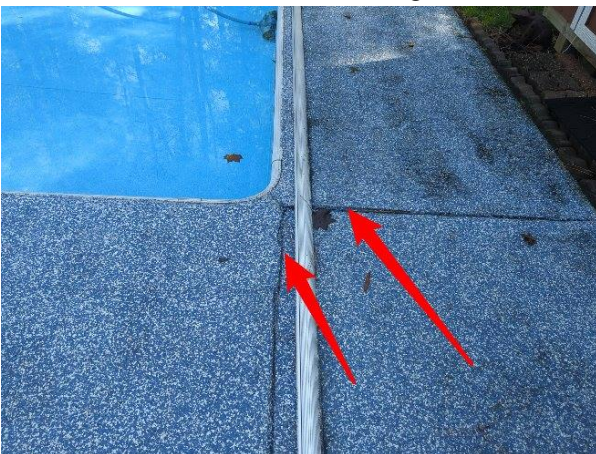
13: There was uneven decking that had created trip hazards. Location: near the shed

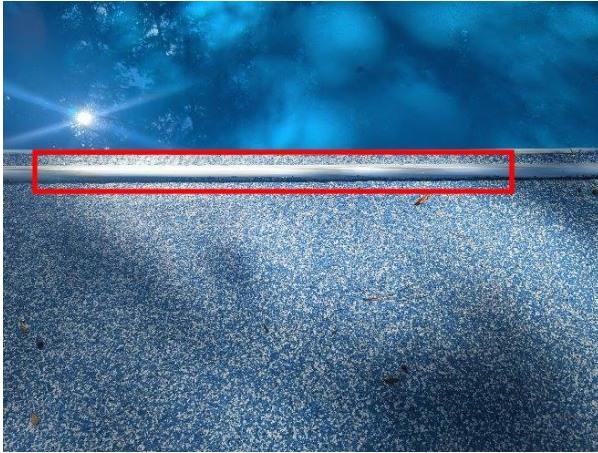
14: The track for the pool cover created a trip hazard around the pool. Cracked as necessary.

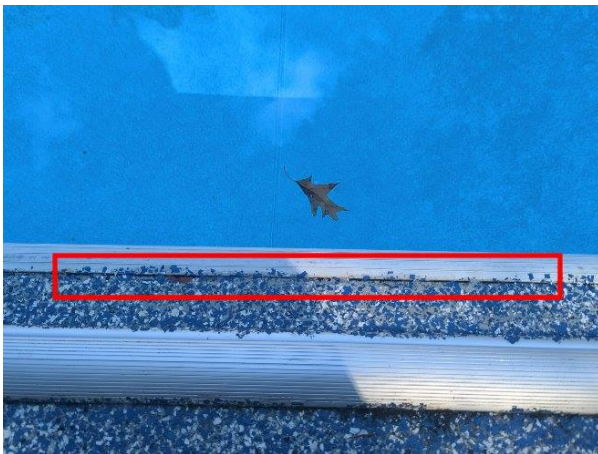
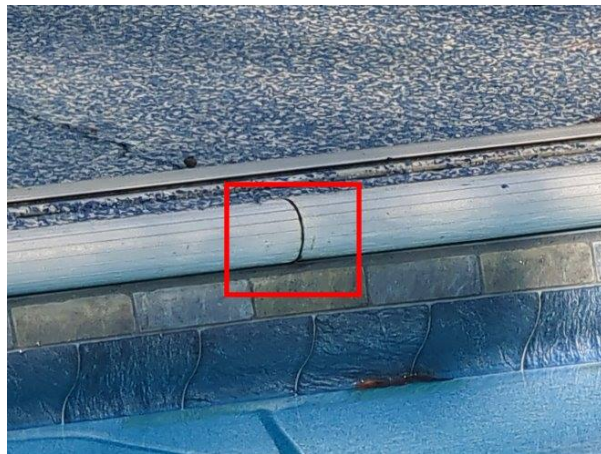
15: The coping around the pool had some separation from itself and from the decking. Recommend correction.

s-15: The coping around the pool had some separation from itself and from the decking. Recommend correction.

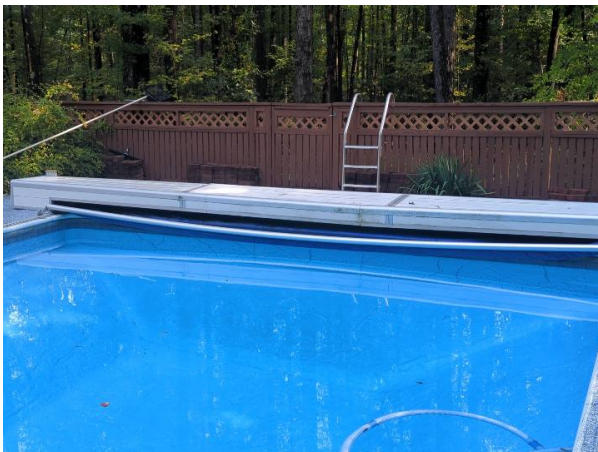
16: The coping in the deep end could not be viewed due to the pool cover.

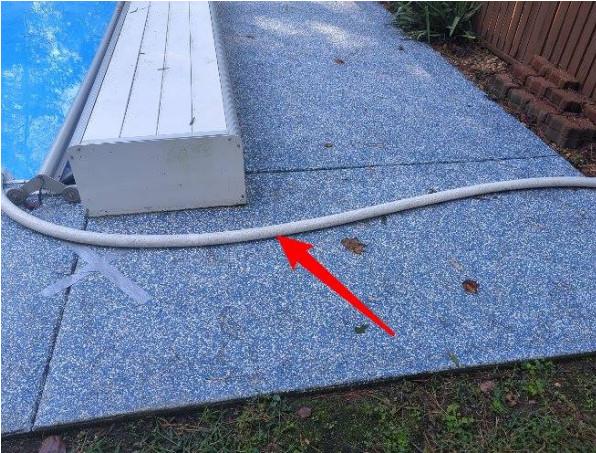
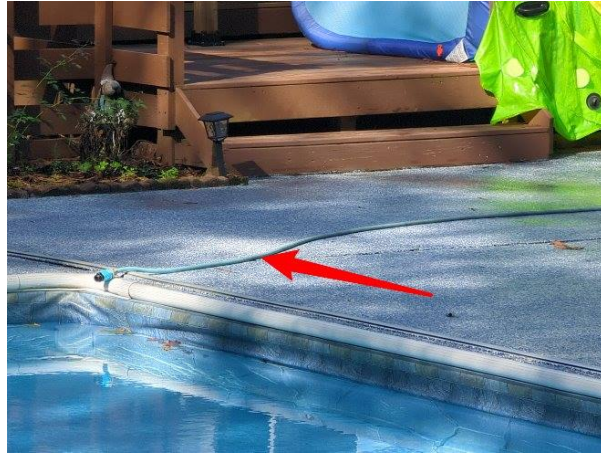
17: There were two hoses running across the decking that would be a trip hazard. Recommend removing these for safety.

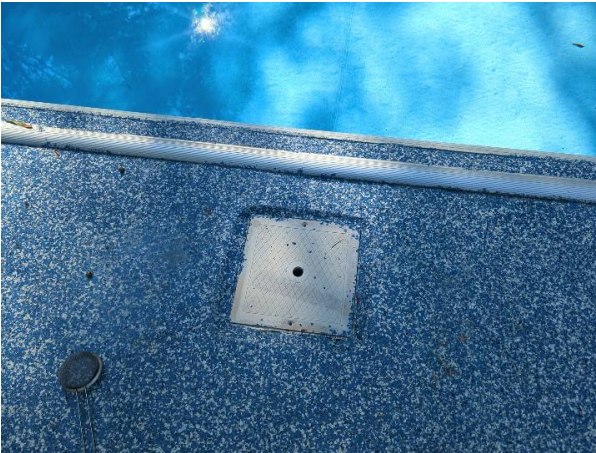
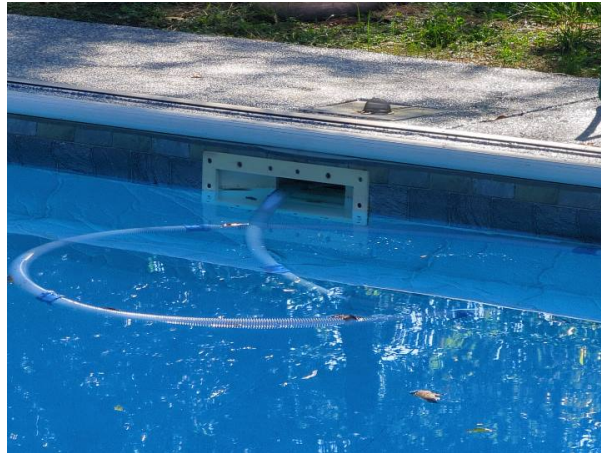
18: The skimmer box and cover were inspected.

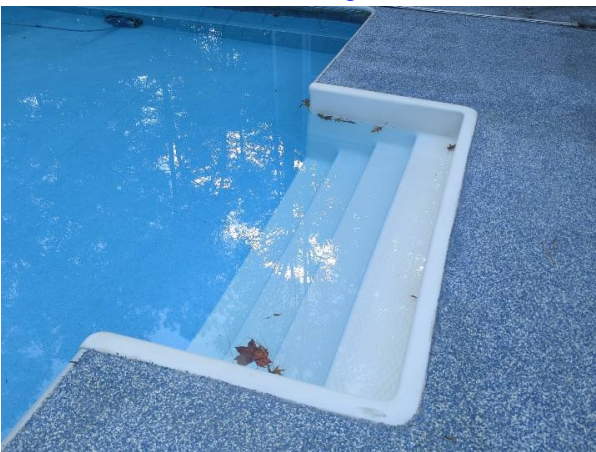
20: Recommend installing a handrail at the steps for safety.

s-20: Recommend installing a handrail at the steps for safety.

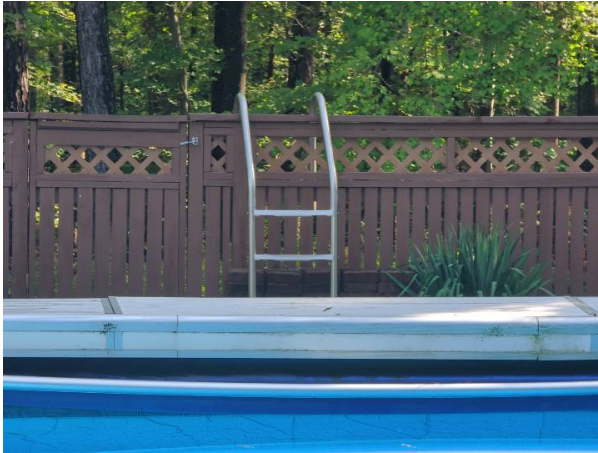
21: There was a ladder for the deep end but it was not installed. Could not verify its proper operation.

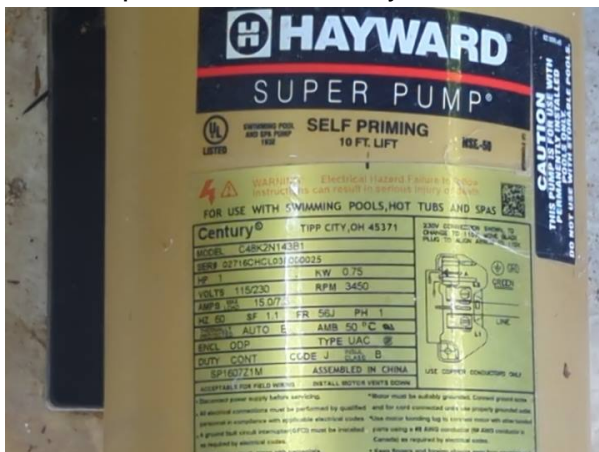
26: Pump Manufacturer: Hayward

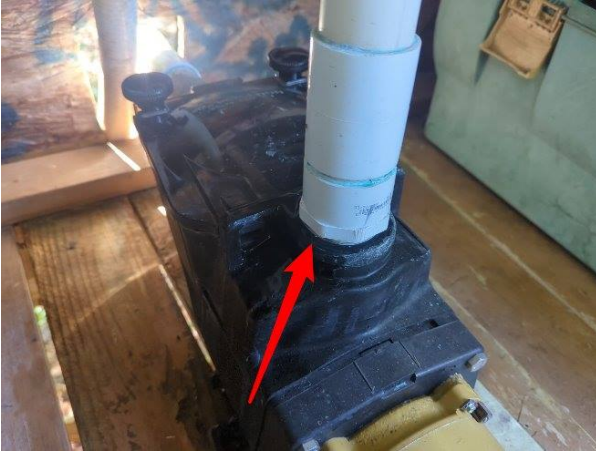
30: The pipe going into the top of the pool pump was leaking.

s-30: The pipe going into the top of the pool pump was leaking.

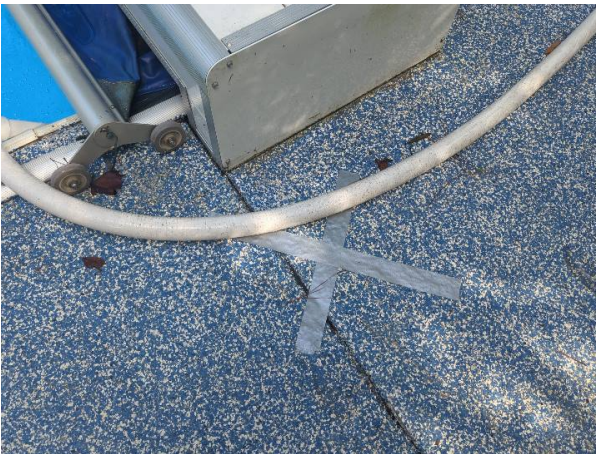
31: The current homeowner stated the pipes are leaking underground at the x on the decking. The hose going into the pool near this. X is a temporary inlet. Current homeowners states this leak will be repaired.

s-31: The current homeowner stated the pipes are leaking underground at the x on the decking. The hose going into the pool near this. X is a temporary inlet. Current homeowners states this leak will be repaired.

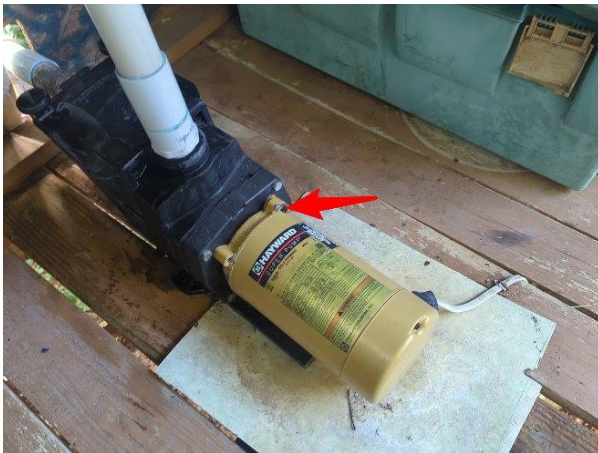
35: The pool pump motor was not bonded as required and should be corrected.

s-35: The pool pump motor was not bonded as required and should be corrected.

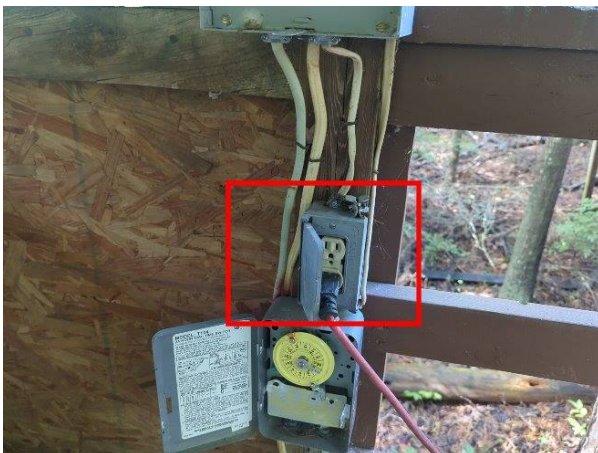
36: There was a receptacle that was not protected by a GFCI in the pool area. Correction is recommended. Location: above the timer box.

s-36: There was a receptacle that was not protected by a GFCI in the pool area. Correction is recommended. Location: above the timer box.

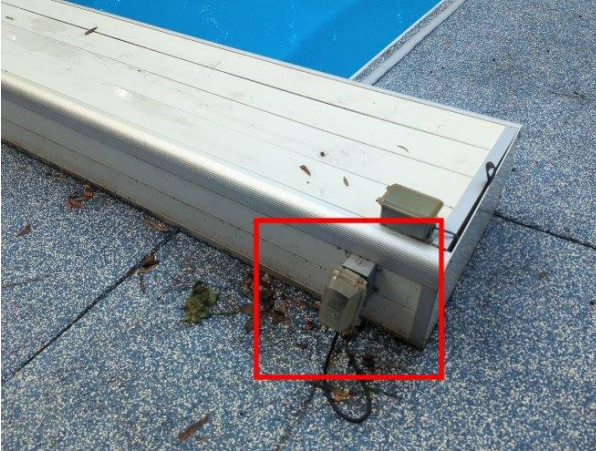
38: There was a receptacle that was too close to the pool and should be terminated or relocated for safety reasons. The receptacle cover was also separated and was in need of repair. Location: connected to pool cover housing

s-38: There was a receptacle that was too close to the pool and should be terminated or relocated for safety reasons. The receptacle cover was also separated and was in need of repair. Location: connected to pool cover housing

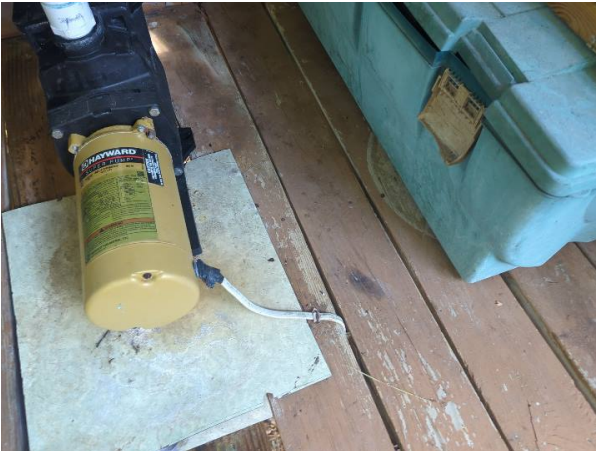
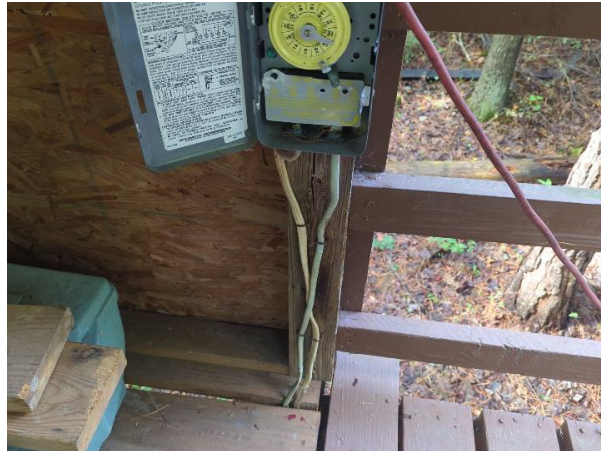
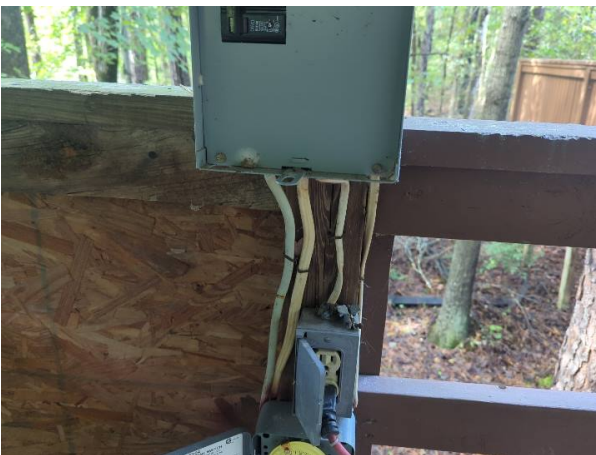
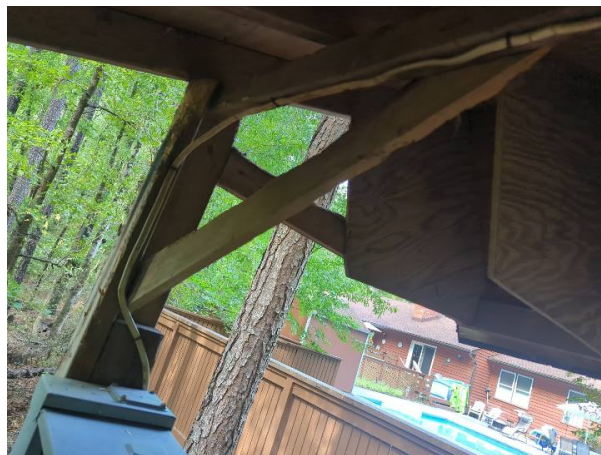
39: The electrical wires in the pump area were not protected. Recommend putting them into a protective conduit.

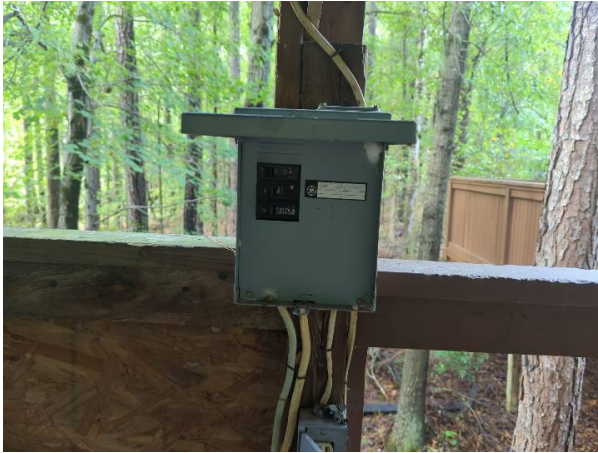
41: There was a sub panel located next to the pool pump.
