Sewer Scope Inspection

LOCATED AT:
123 Main St
Richmond, VA 23221

INSPECTED ON:
Thursday, November 16, 2023

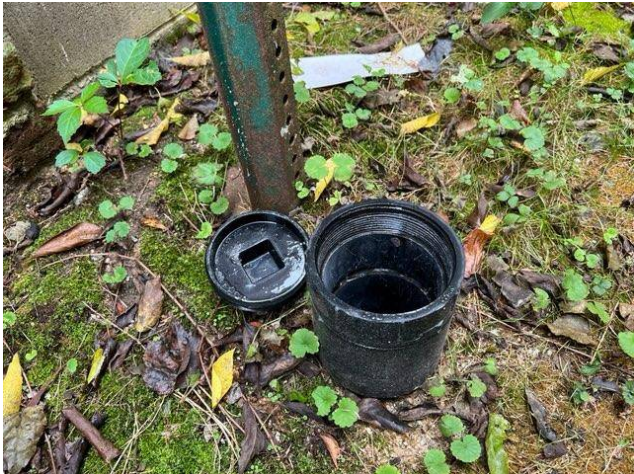
6: The clean out access was in good condition.

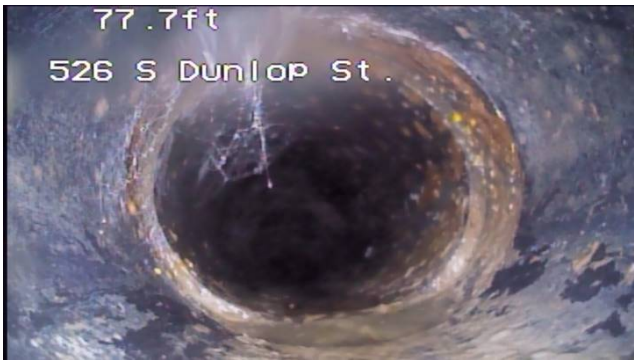
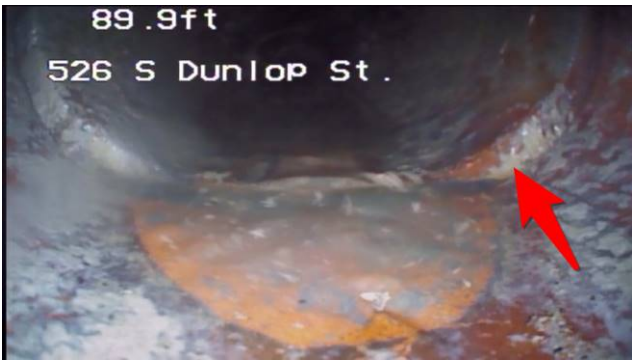
12: An offset was visible in the main sewer line/pipe at approximately 89 feet from the access point.

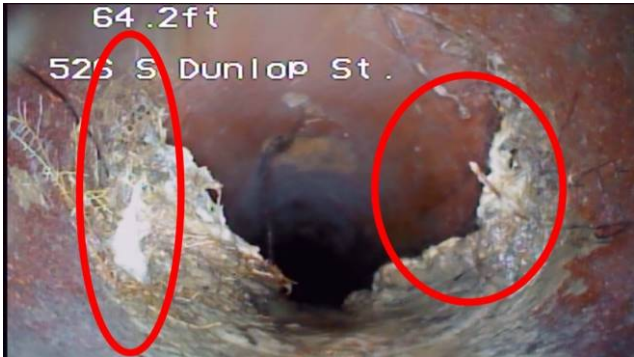
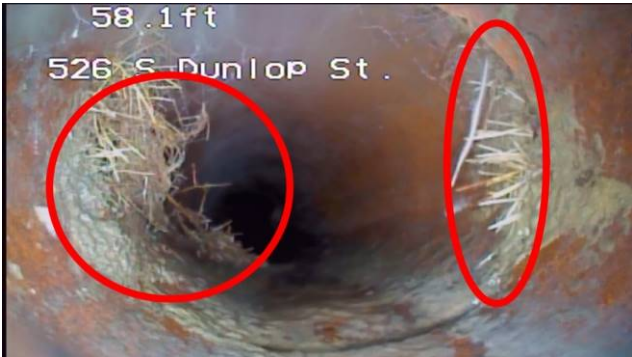
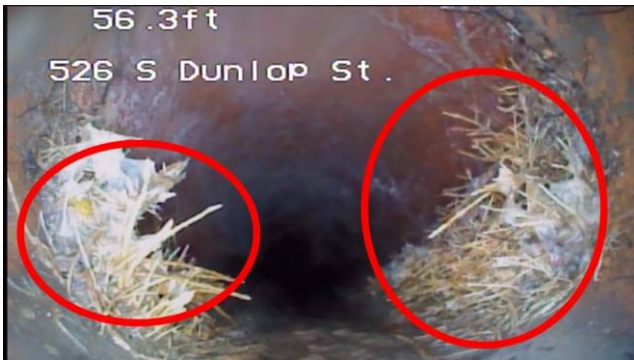
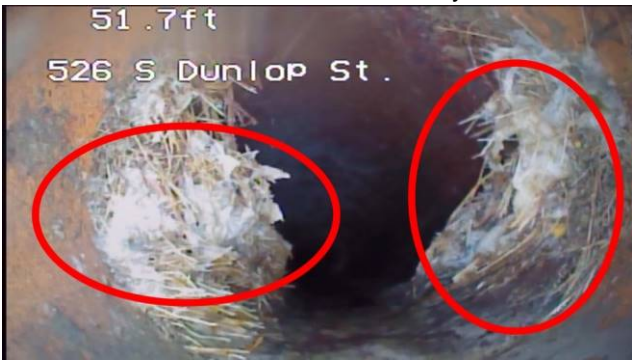
13: Root intrusion at a joint was visible in the main sewer line/pipe at multiple locations.

17: The main sewer line/pipe should be cleaned for roots annually to minimize the potential for blockage.

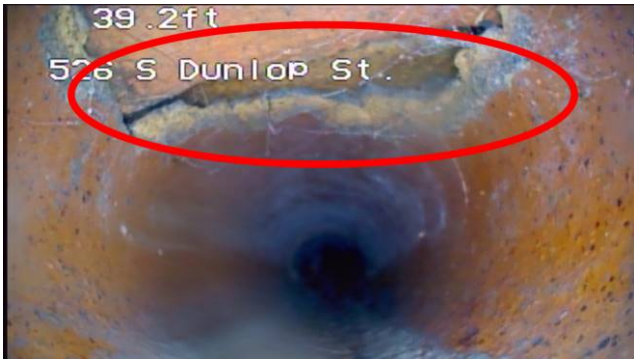
14: The main sewer line/pipe appeared to be broken / damaged at approximately 39 feet from the access point.

18: The clay portion of the pipe was damaged at approximately 39 feet from the access point. The main sewer line/pipe should be repaired or replaced as needed and re-inspected with a camera.

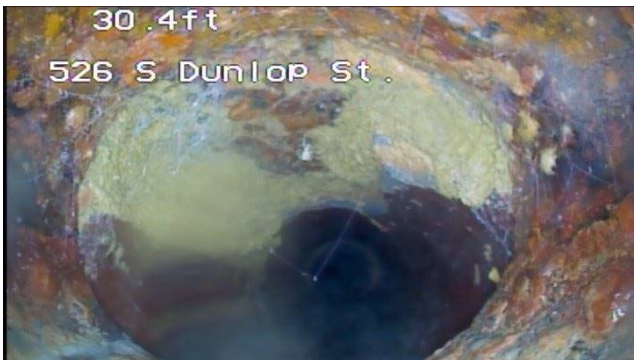
15: Heavy rust / scale was visible in the cast iron portion of the main sewer line/pipe.

Rust and corrosion on the cast iron portion.

19: Once the repair has been made, the pipe should be cleaned / hydro-jetted of roots, grease, and scale, and re-inspected with a camera.

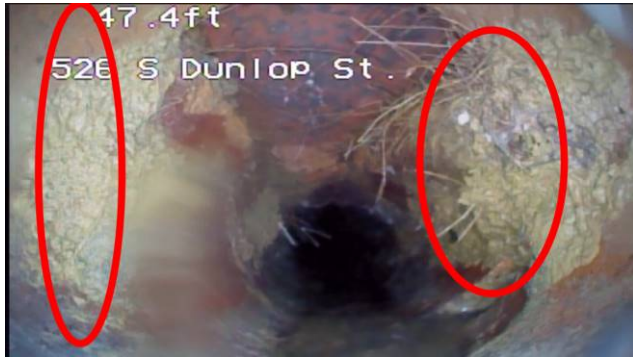
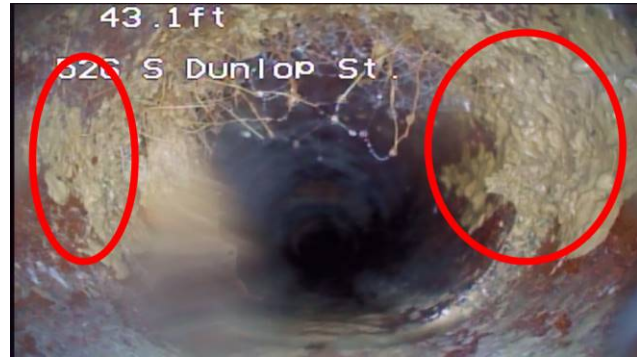
16: Heavy grease build up was visible in the main sewer line/pipe.
