Confidential Mold Assessment Report

LOCATED AT:
820 West Main St
Charlottesville, VA 22903

INSPECTED ON:
Thursday, November 16, 2023

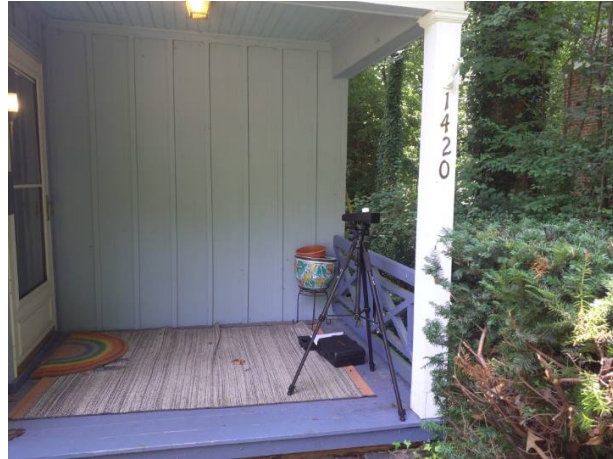
Control sample at front of home

5: Control sample taken at front of home.

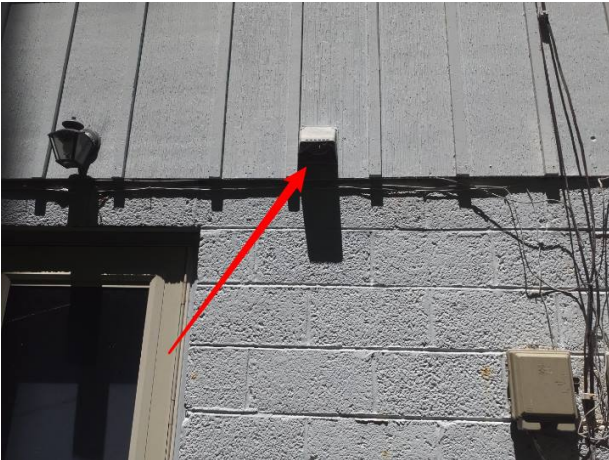
Back of home and interior

8: The dryer vent appeared to be clogged and needs to be cleaned.

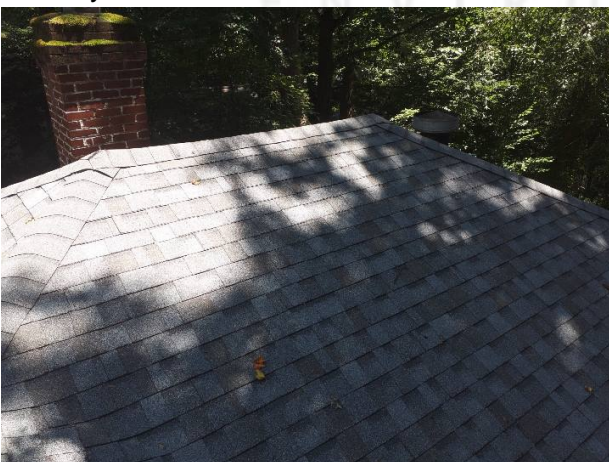
Representative photo

9: The roof was in good shape appearing to have been replaced or reroofed (a second layer added) recently.

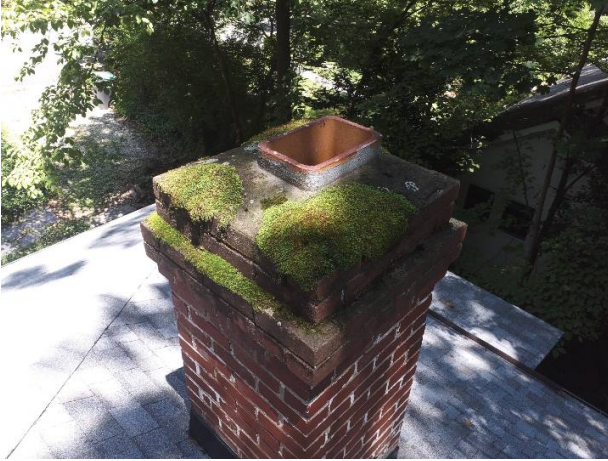
Chimney

10: The chimney cap had moss growing on it with mild deterioration and no rain cap or cover at the top.

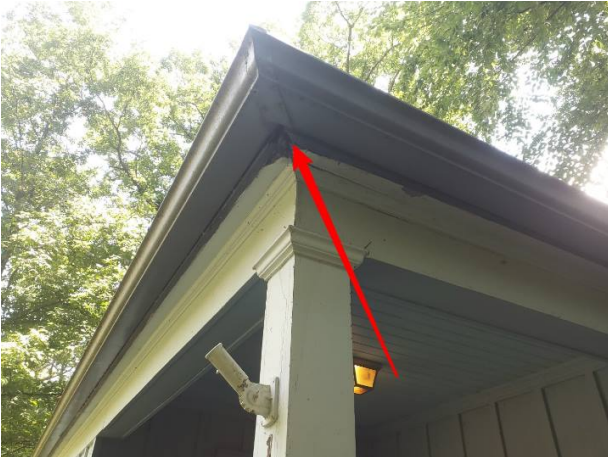
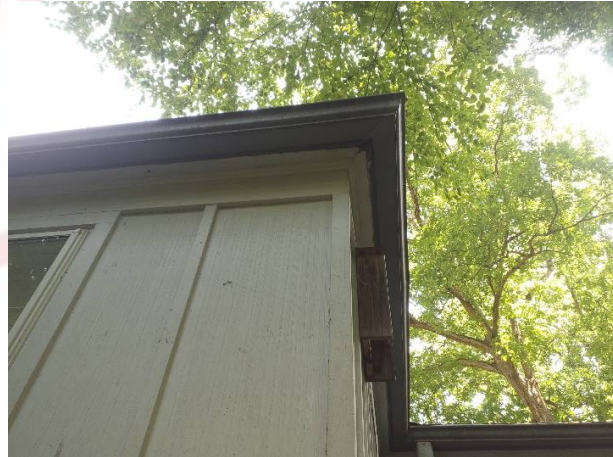
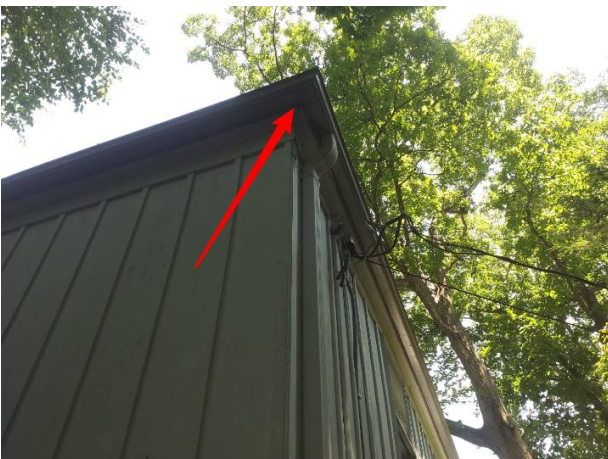
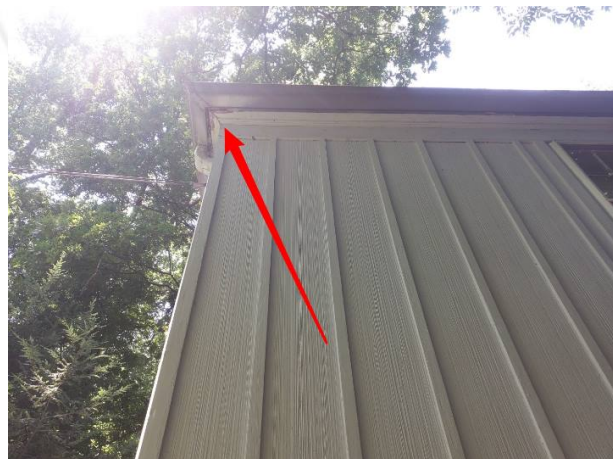
11: The soffit and fascia had areas of damaged and rotted wood. Based on the appearance of the roof this may be older damage that was never repaired.

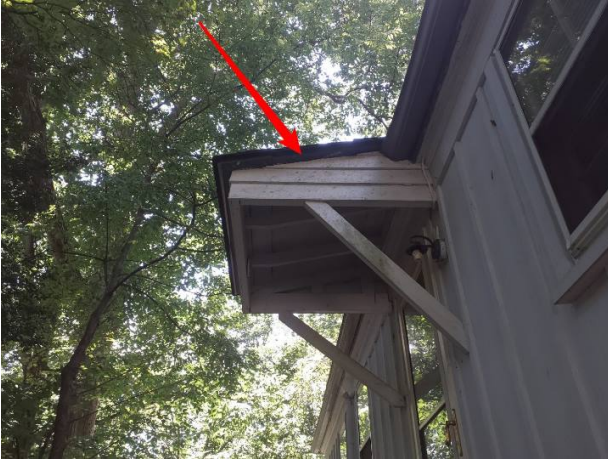
Left side of home

12: There was no drip edge visible on the rake edges of the porch roof overhang.

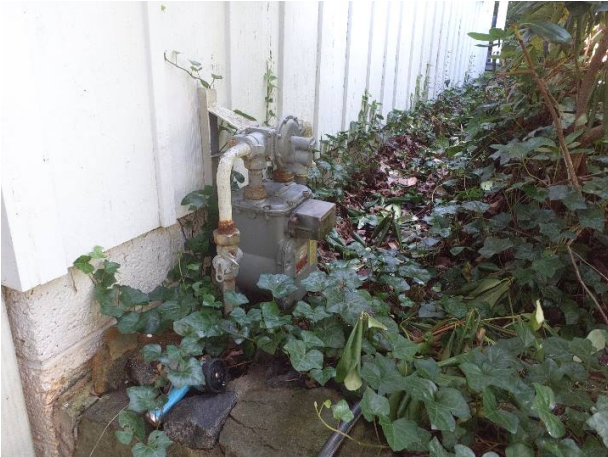
Front of home

13: Vines were in contact with the exterior/siding of the home. This is conducive to insects and moisture. Recommend all vegetation be removed from close proximity to the home.

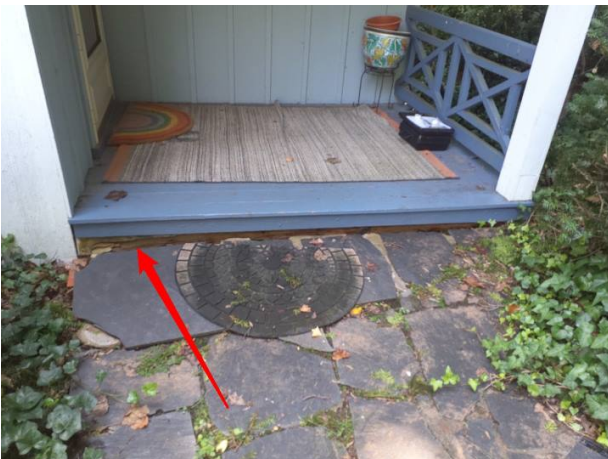
Front of home

14: Significant wood rot and deterioration noted at the front porch area.

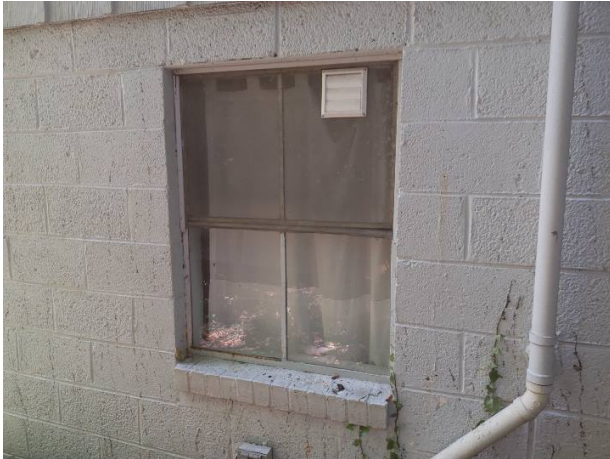
Left side of home

15: Some windows were older, single pane, metal frame and not sealed well. This may be a source of moisture intrusion into the home.

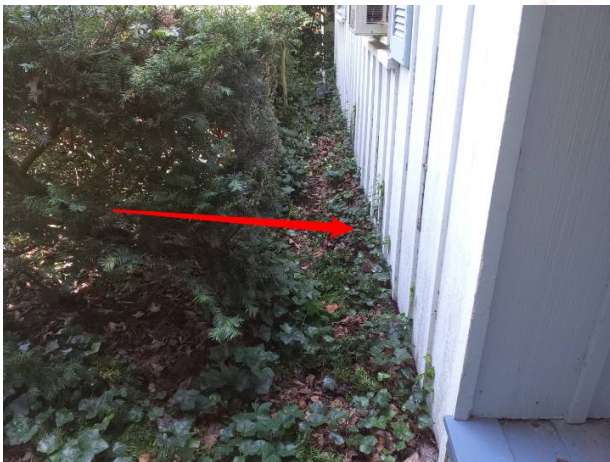
Front of home

16: Negative grading noted around the front of the home.

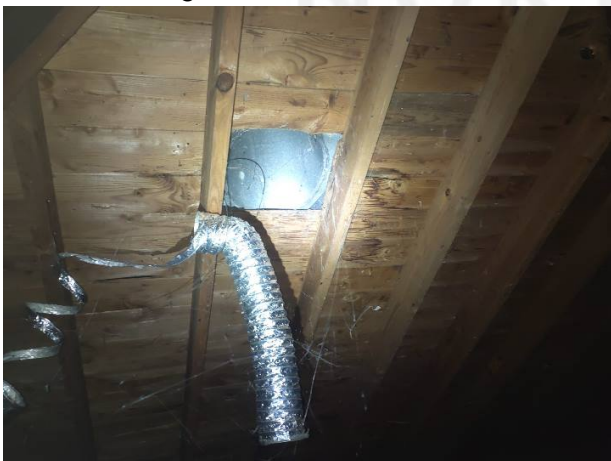
20: Ventilation in the attic may be inadequate for this space. Recommend a qualified professional evaluate and give recommendations.

Only visible vent

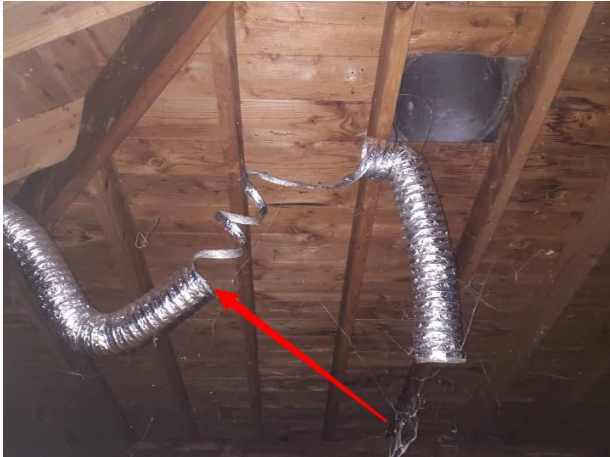
Attic

21: The bath fan exhaust vent was broken or disconnected and did not appear to be venting to the exterior. On daily moisture from shower should be vented to the outside.

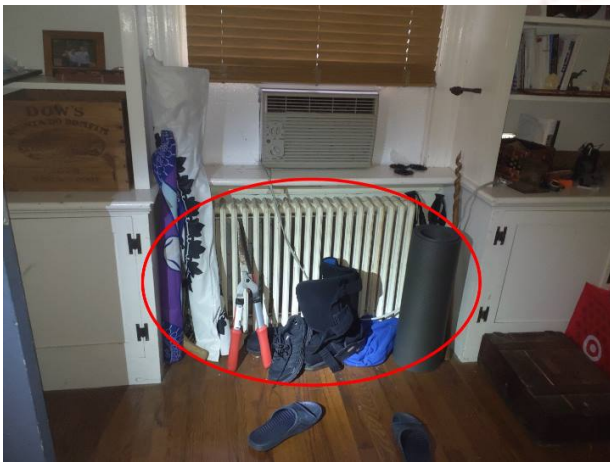
Living room

22: There were moisture stains and deteriorated plaster below the living room window AC unit. Recommend evaluating the function of the window unit to ensure proper operation. The area appeared dry at the time of inspection.

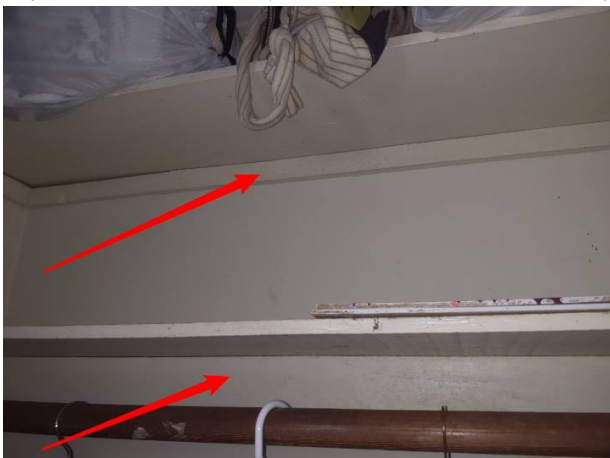
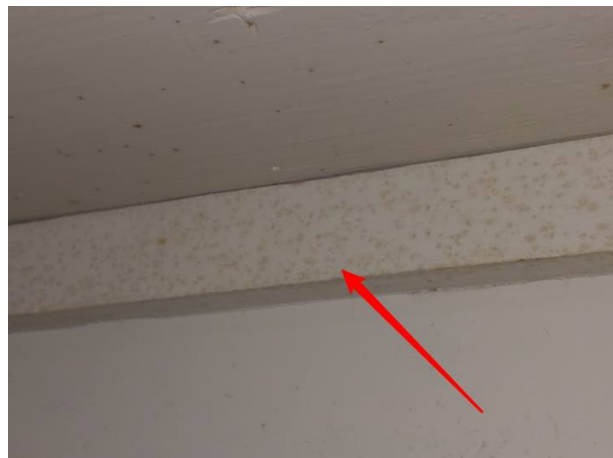
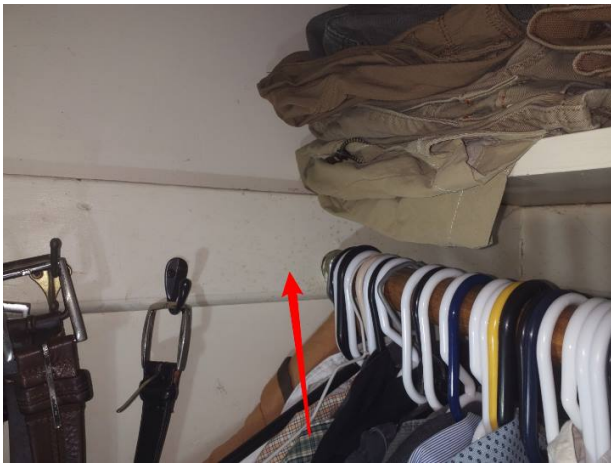
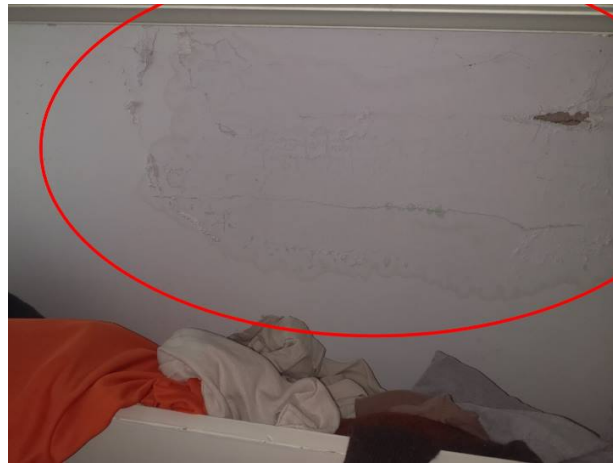
23: There was water staining, discoloration and spotting noted in the bedroom closets. The areas were dry at the time of inspection and the stains may be older.

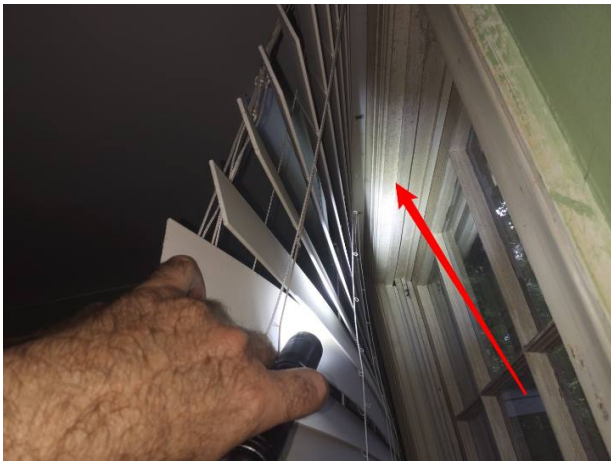
Back left bedroom

24: There was spotting and discoloration around some of the window areas. The area was dry the time of inspection.

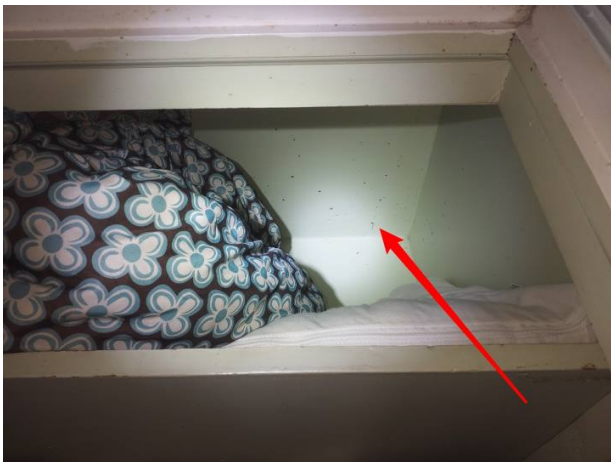
Bathroom closet

25: Black spotting or suspicious bio growth was noted in the ceiling of the closet in the bathroom.

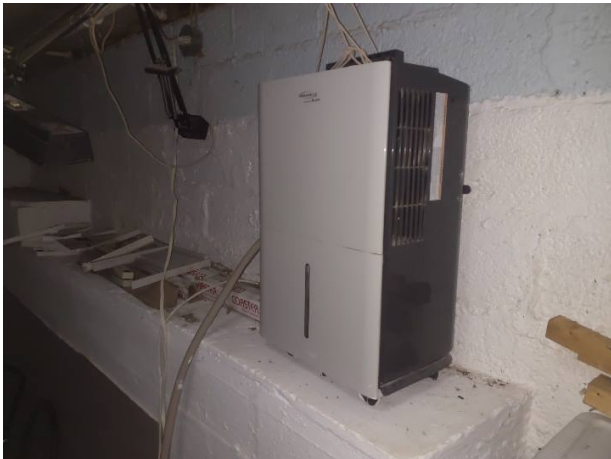
Representative photo

26: There were two dehumidifiers in the basement, only one of which was operating at the time of the inspection.

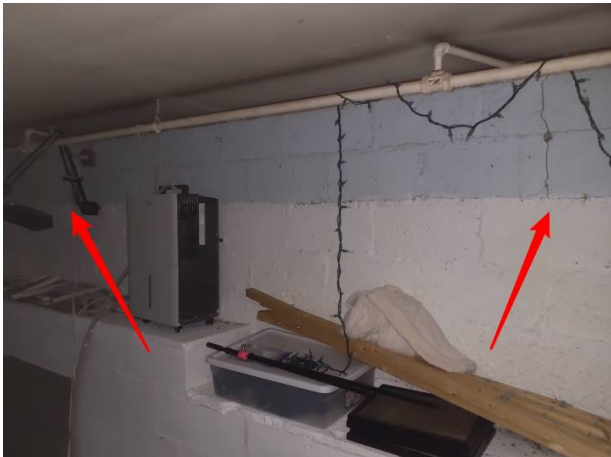
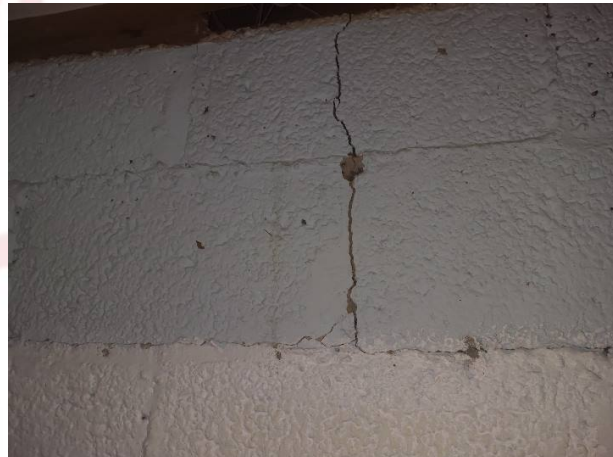
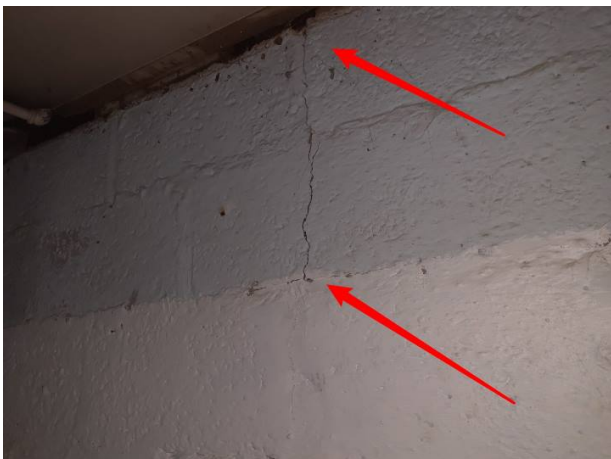
27: There were a couple of vertical foundation cracks noted at the front of the basement area. Recommend a licensed professional evaluate these cracks and determine their cause.

Front of basement, possible hydrostatic pressure

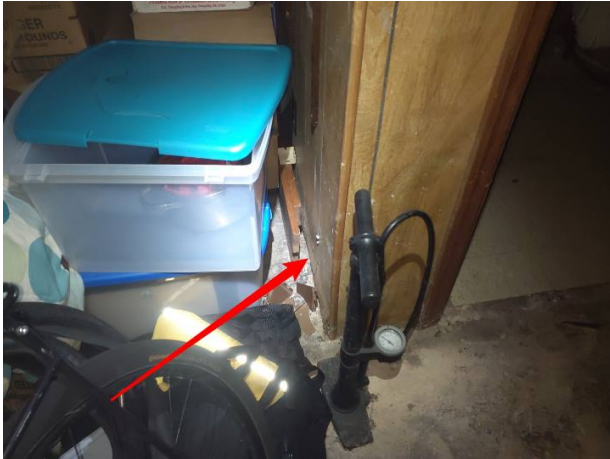
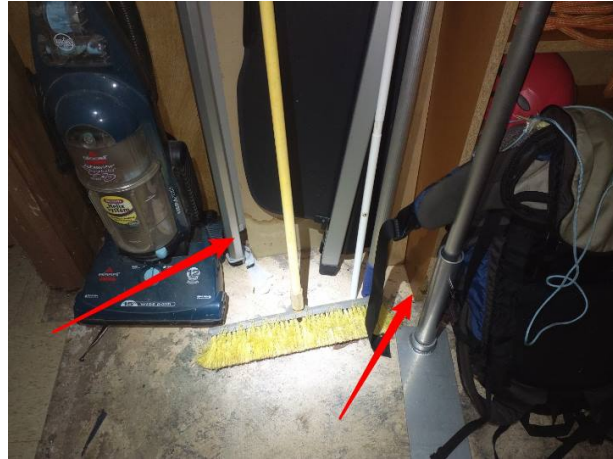
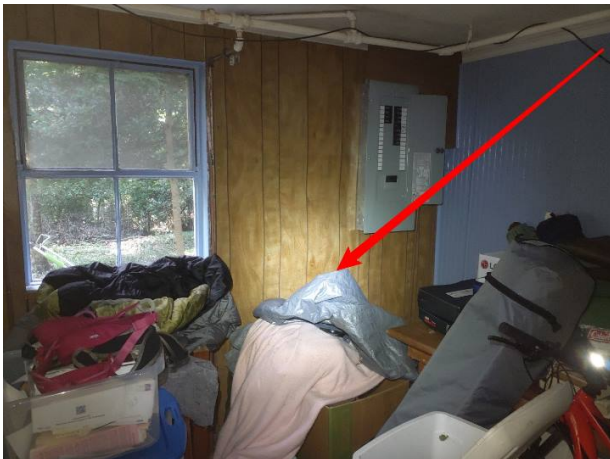
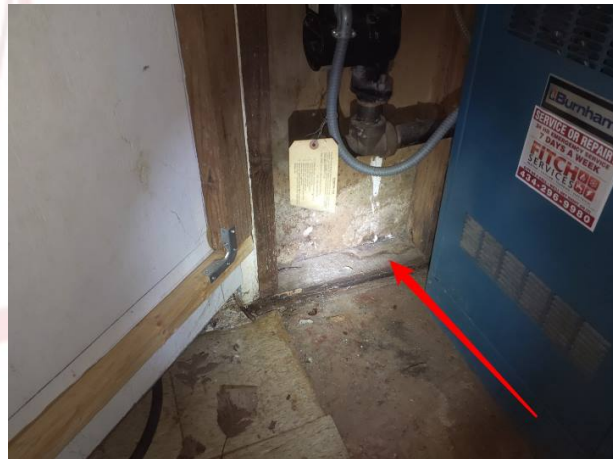
28: There was water staining and damaged drywall/paneling around the floor of the basement. Recommend removing items, drywall and paneling for better inspection of possible damage.

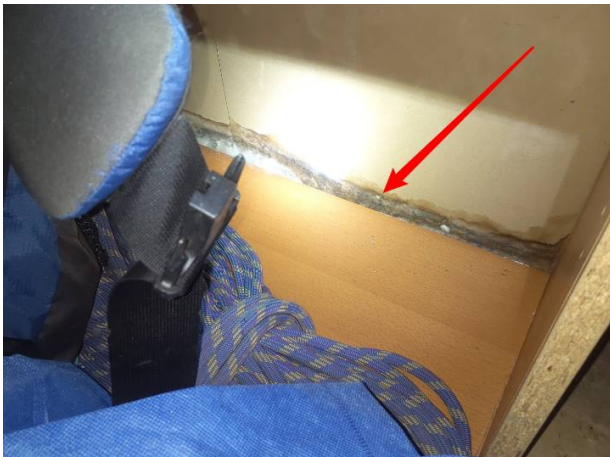
Basement storage

29: Significant water staining, discoloration and suspicious bio growth noted behind the shelf in the basement. Client declined tape lift sample.

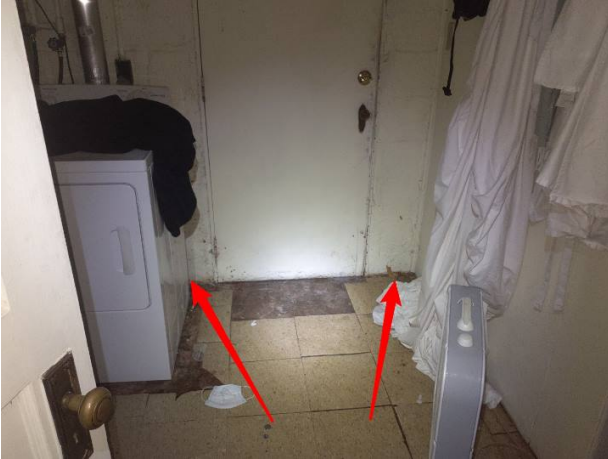
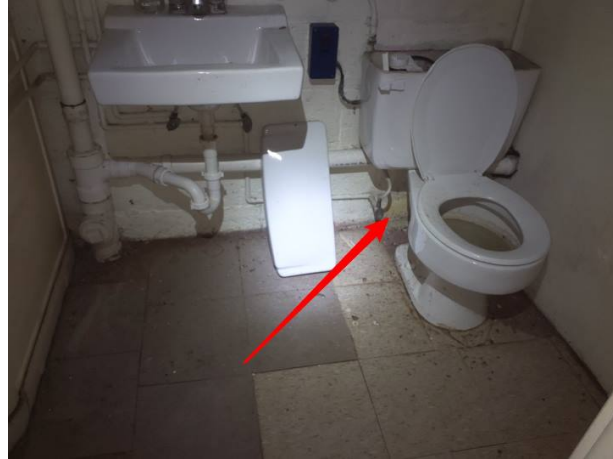
30: Water staining and efflorescence was noted on some of the exterior walls of the basement.

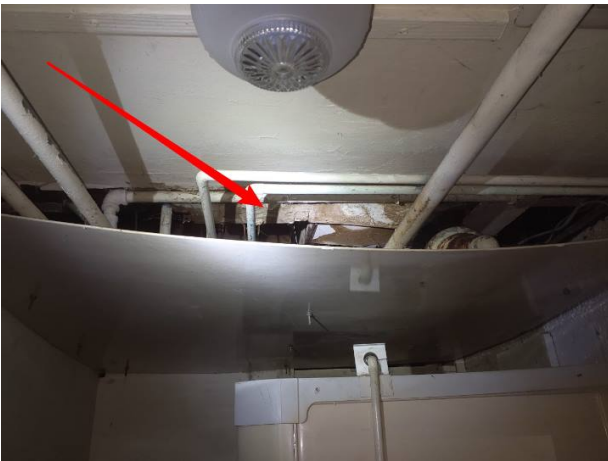
Basement bathroom

31: Dry stains and past water damage noted in the ceiling of the basement bathroom.

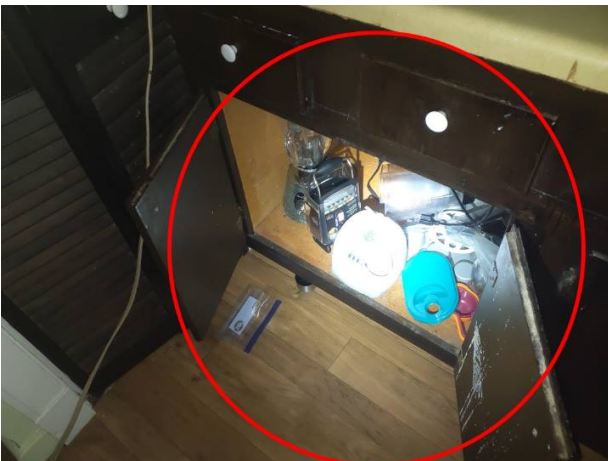
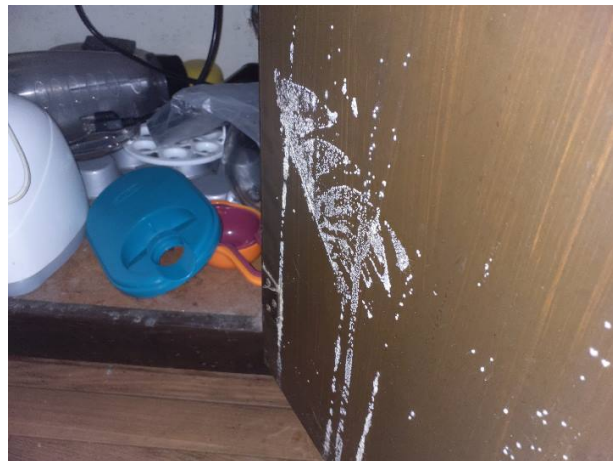
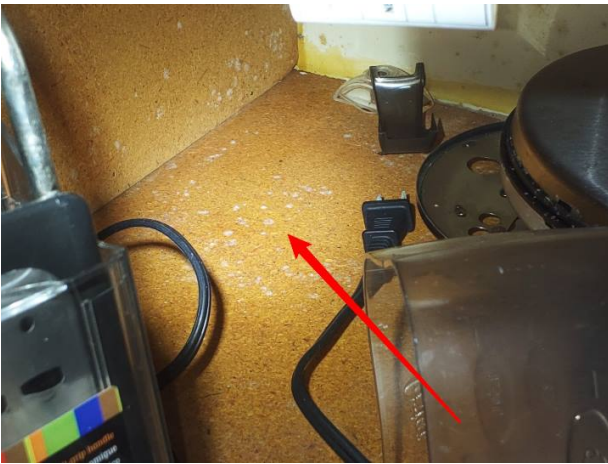
32: White spots or suspicious bio growth was noted inside the kitchen cabinetry. This area was dry at the time of inspection and these may be resulted from food particles in the area. Recommend thorough cleaning of the home.
